# **Demonstration and Validation of Materials for Corrosion-Resistant Fencing and Guard Railings in Aggressive Climates**

Final Report on Project F09-AR02

October 2015

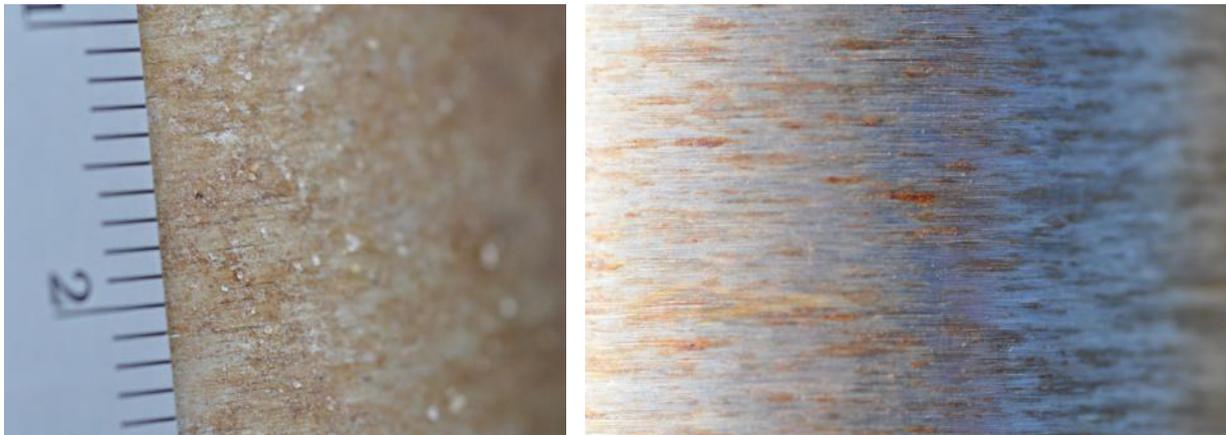
Figure 35. Stainless steel railing coupon at FRF (left) and KTA (right) after 12 months of exposure.

Railing Material Type	Corrosion	Staining	Comments
Stainless steel	80%	Oxidation	Surface oxidation has discolored the material.
Aluminum	<5%	Pitting	Pitting has begun in areas where the anodize may have been damaged
Coated steel	20%	Rust	Rust has begun to form where the coating has failed. Discoloring of the coating due to the rust.
FRP	25%	UV	Discoloring due to UV exposure on the face of the railing that faces the sun

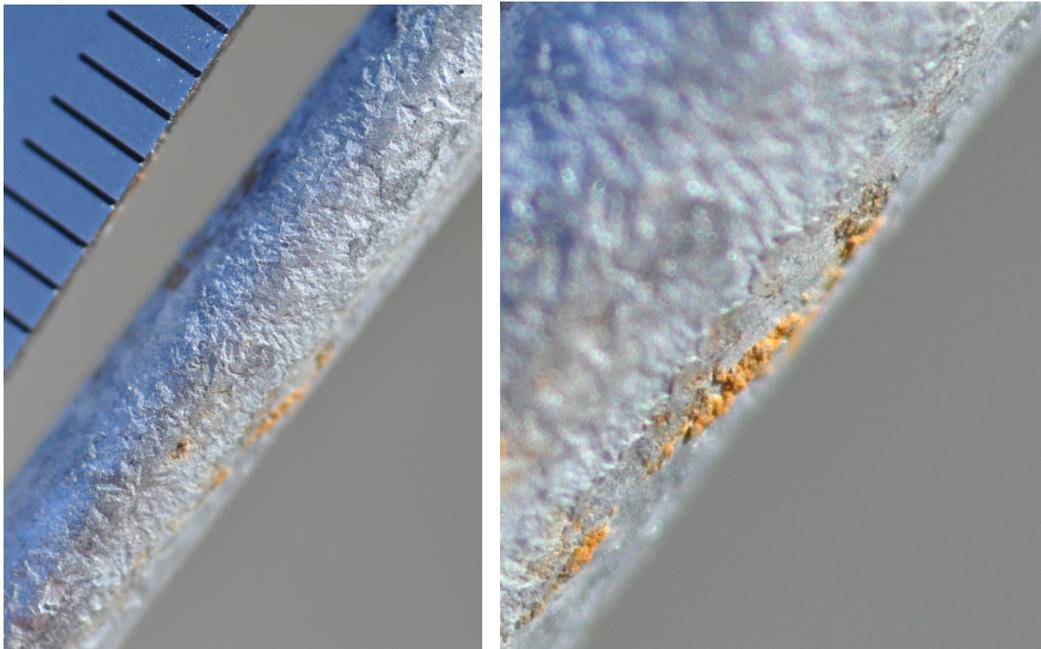
Figure A14. Aluminized after 12 months exposure showing corrosion on less than 5% of the total surface area.
