THE SECRETARY
OF THE INTERIOR'S
STANDARDS FOR
REHABILITATION &

ILLUSTRATED
GUIDELINES ON
SUSTAINABILITY
FOR
REHABILITATING
HISTORIC
BUILDINGS

U.S. Department of the Interior
National Park Service
Technical Preservation Services

2011

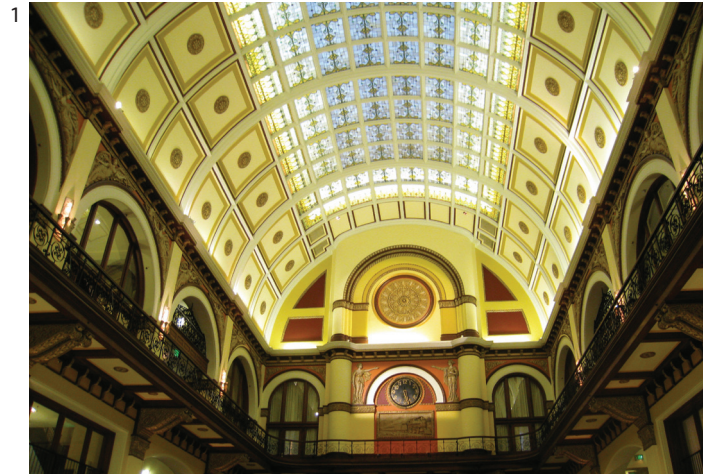
[1] Stained glass skylight provides natural light in a historic train station.

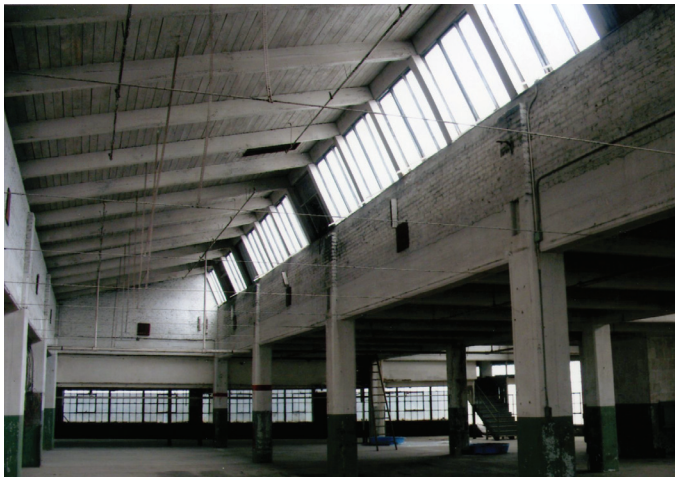
[2-3] Clerestory windows provide natural light in a historic industrial building: Before and after rehabilitation.

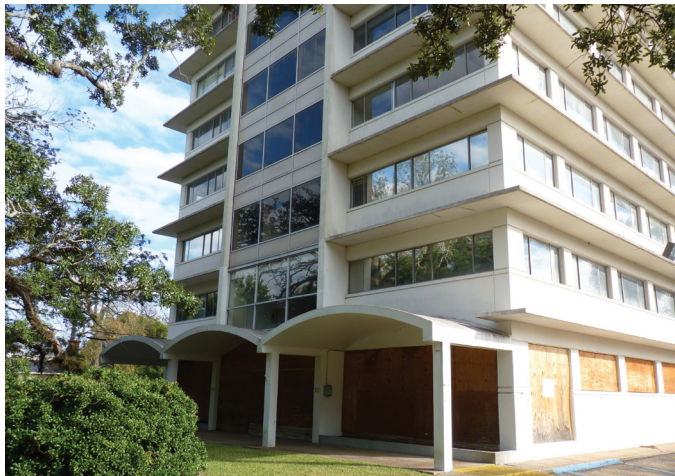
[4] Covered walkways and horizontal sun screens are distinctive and sustainable features in some mid-century modern office buildings.

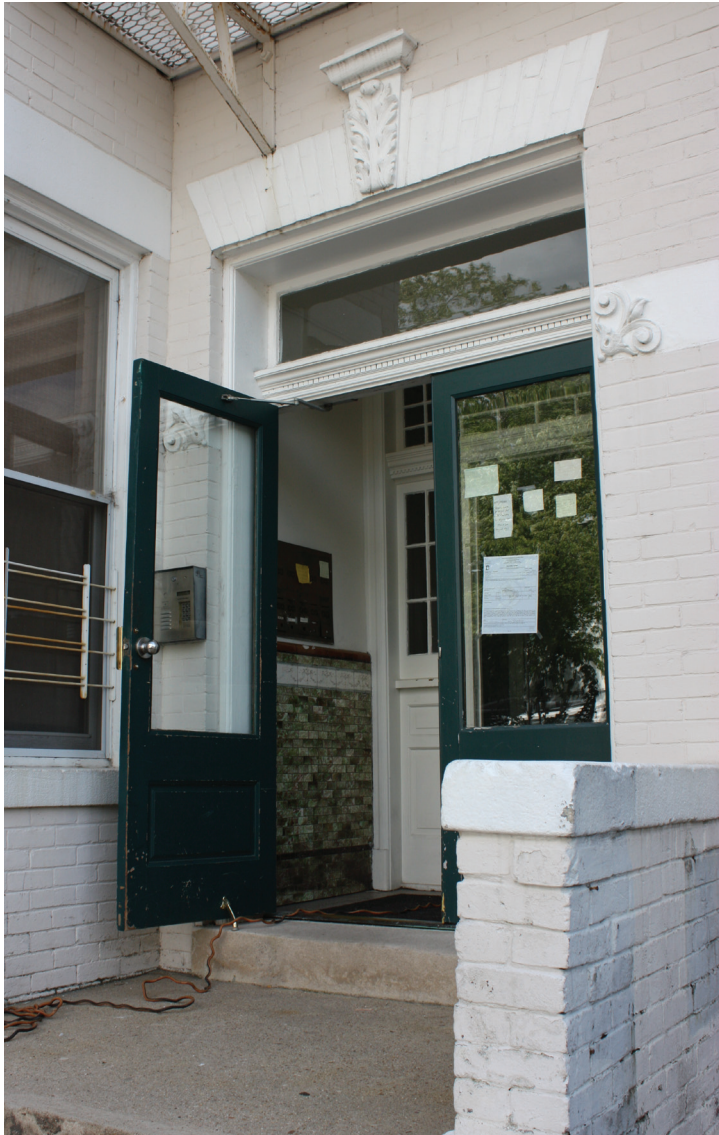
[11] A vestibule helps retain interior conditioned air in the living space in this historic row house.

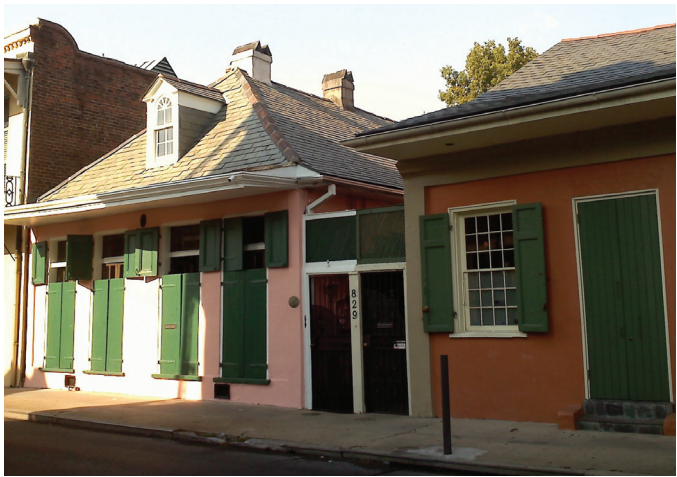
[10] Wood shutters provide natural light when open and keep interiors cool when closed in historic residential buildings.

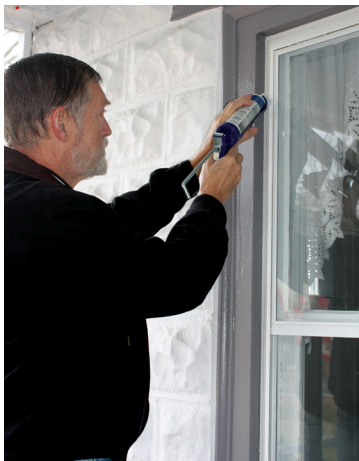
Recommended: [19] Caulking the gap between the aluminum storm window and wood window frame helps maximize thermal efficiency in this historic residence.

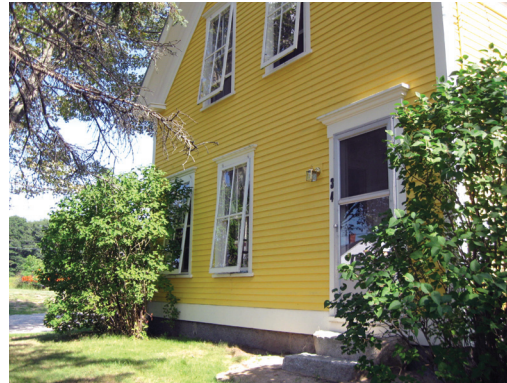
Not Recommended: [27] A broken sash cord can be repaired easily and does not justify replacement of the window.

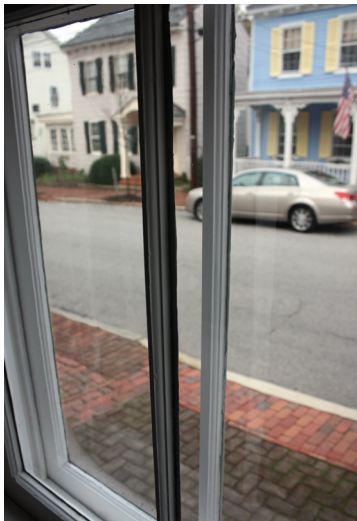
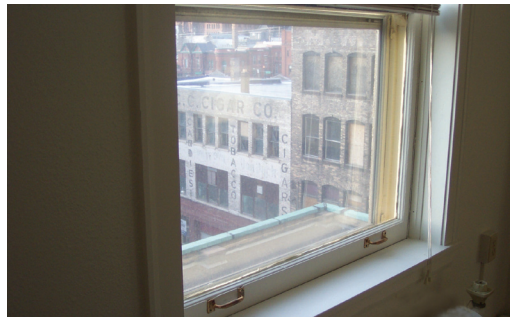
Recommended: [28-29] These exterior storm windows match the pane configuration of the historic interior windows in a residence and in a multi-story hotel building.

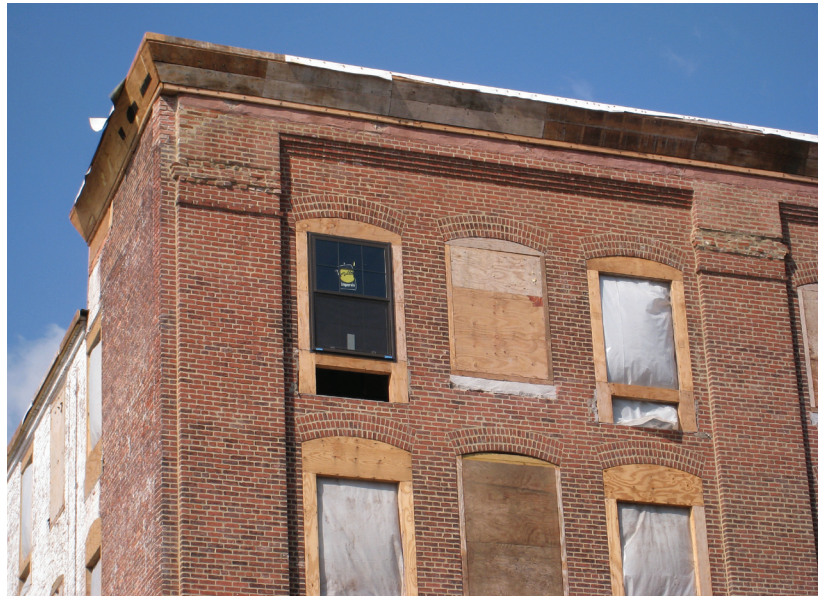
Recommended: [33-35] Original metal windows were appropriately repaired as part of the rehabilitation of this historic industrial building.

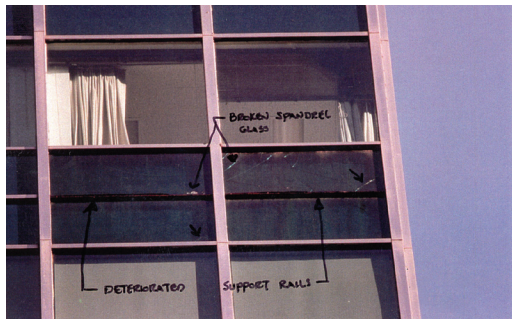
39
Recommended: [39-40] The original windows, which were deteriorated beyond repair, featured a dark tint. They were replaced with a slightly lighter-tinted glazing to improve daylighting in this mid-century modern office building.

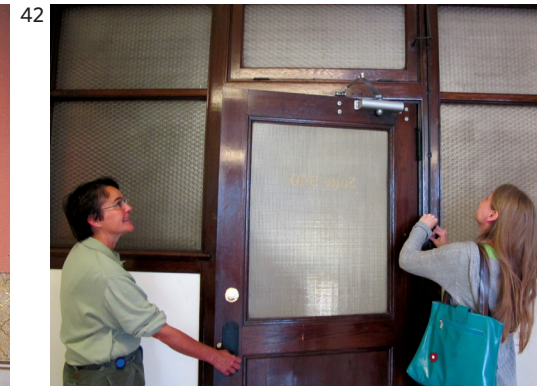
Recommended: [43] The wall and door glazing ensures that the corridor receives natural daylight and the operable transom helps air to circulate in this historic office building.

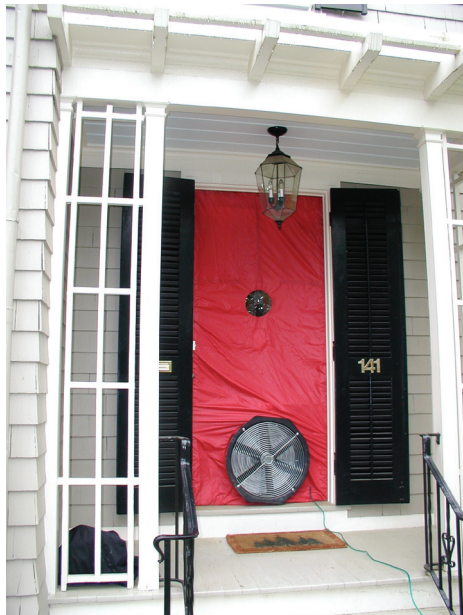
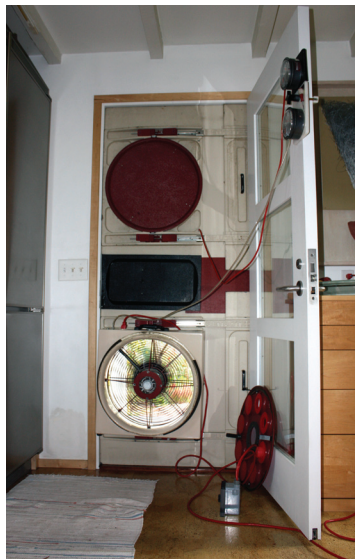
Recommended:
[44-45] A blower door test is a useful tool to help identify air infiltration in a historic building before undertaking weatherization or retrofit treatments.
Top Photo: Robert J. Cagnetta, Heritage Restoration, Inc.

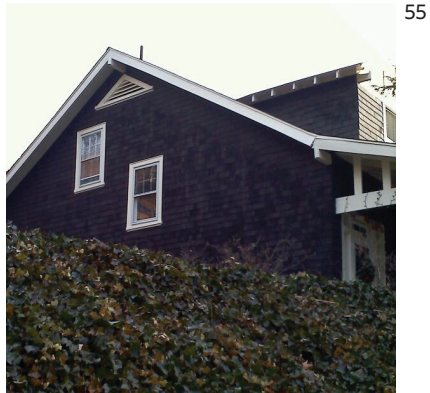
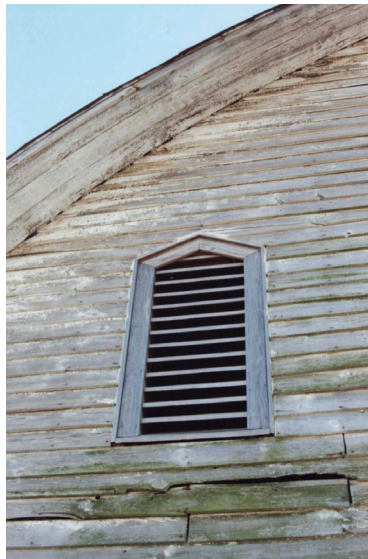
Recommended: [55-57]
Wood vents in the gable ends of a historic house and a barn and cast-iron oval vents in a masonry foundation traditionally helped air circulate.

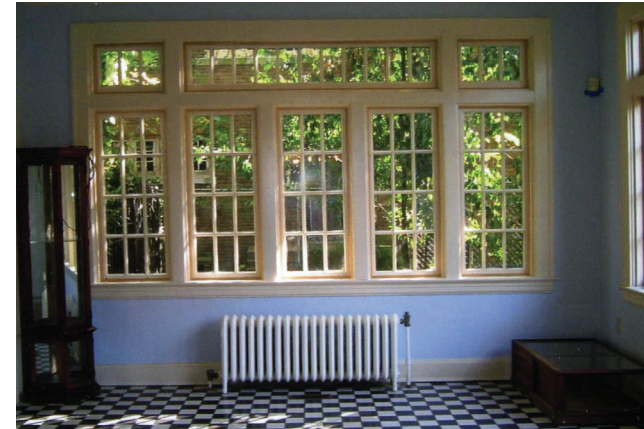
Recommended: [60] Original radiators that are still functional and efficient were retained in the rehabilitation of this historic house.

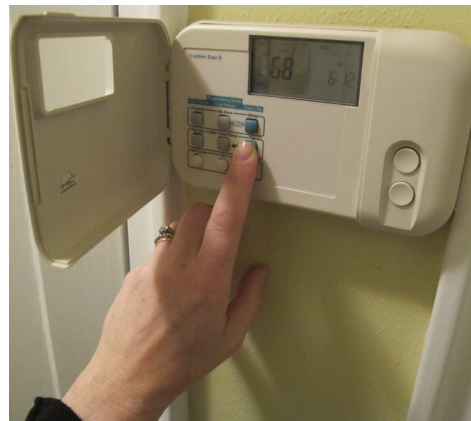
Recommended: [59] Installing a programmable thermostat can help existing systems to operate more efficiently.

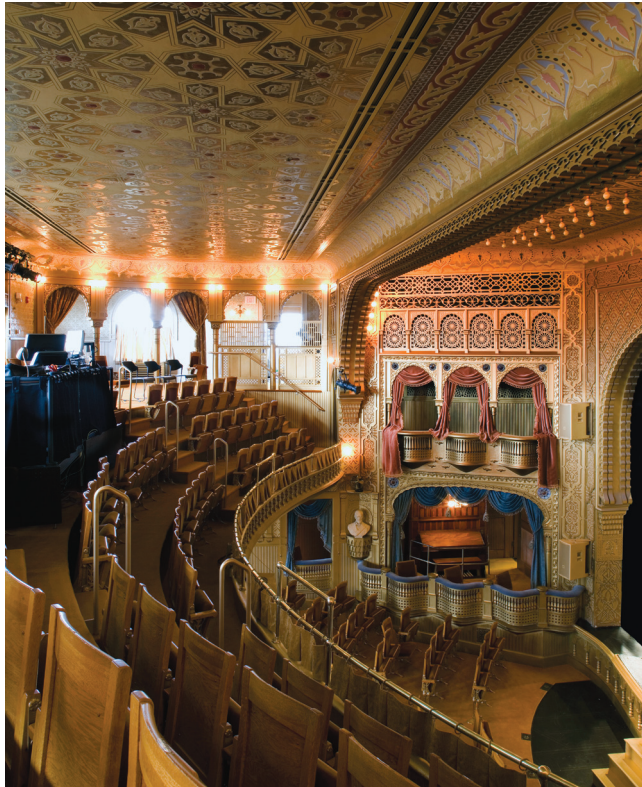
Recommended: [62-63] Carefully installed new mechanical ductwork is barely visible in the elaborately decorated ceiling of this historic theater.
 [64] The ductwork has been left unpainted which is compatible with this historic industrial interior.
 [65] To avoid damaging the metal ceiling, the ductwork was left exposed and it was painted to minimize its impact, thus preserving the historic character of this former bank.

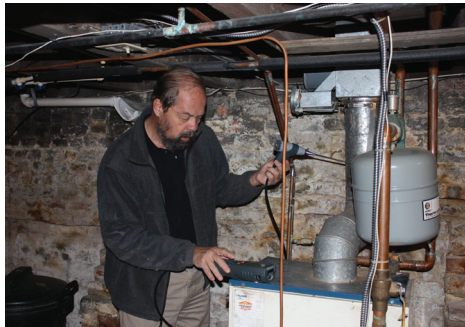
Recommended:[67] A professional energy auditor analyzes the performance of an existing furnace to ensure it is operating efficiently.

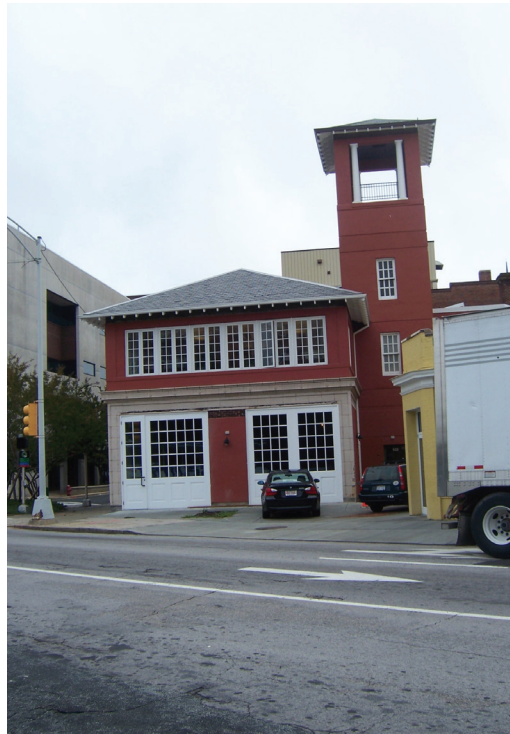
[68-69] A geothermal system, evidenced by a panel in the sidewalk, was installed on the site of this historic firehouse during rehabilitation.

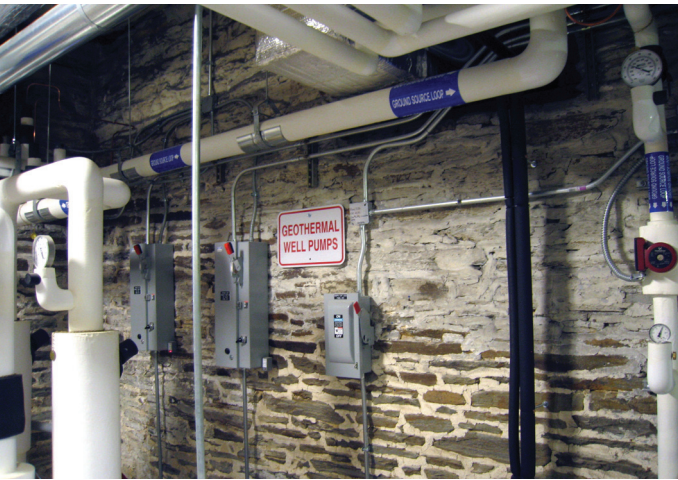
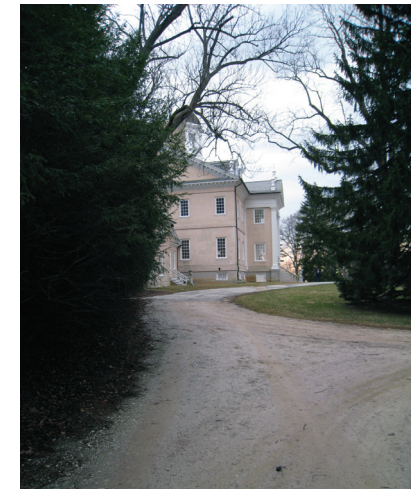
Recommended: [70-71] A geothermal system was installed on the property of this historic mansion, but only after an archeological investigation was conducted of the grounds.

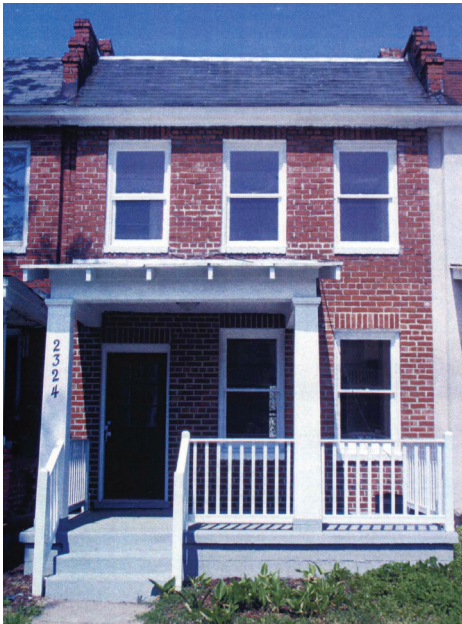
Recommended: [72-73] Solar panels were installed appropriately on the rear portion of the roof on this historic row house that are not visible from the primary elevation.

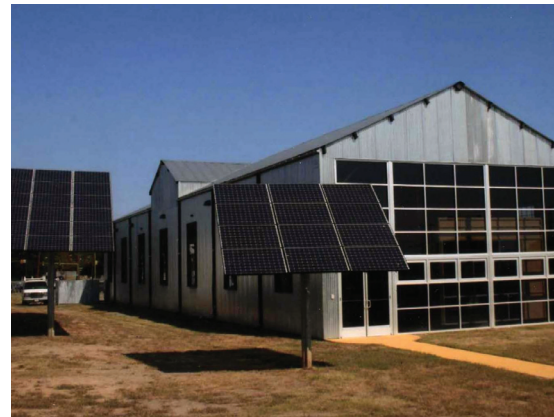
Recommended: [74] Free-standing solar panels have been installed here that are visible but appropriately located at the rear of the property and compatible with the character of this industrial site.

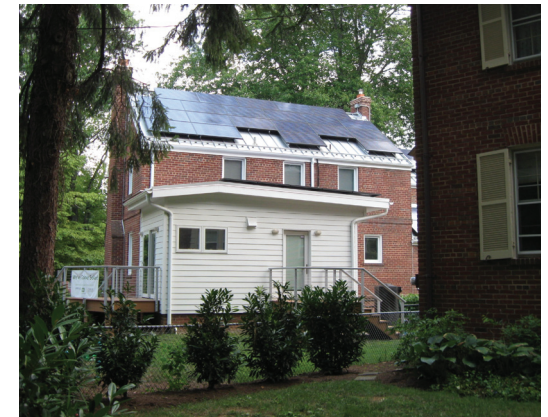
Not Recommended: [75] Solar roof panels have been installed at the rear, but because the house is situated on a corner, they are highly visible and negatively impact the character of the historic property.

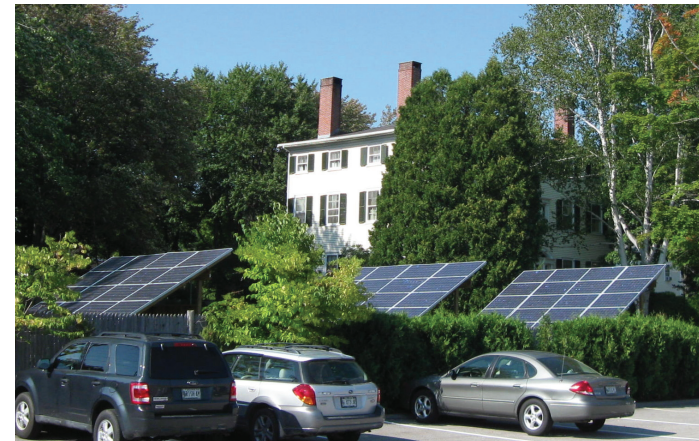
Not Recommended: [79] Although installing solar panels behind a rear parking lot might be a suitable location in many cases, here the panels negatively impact the historic property on which they are located.

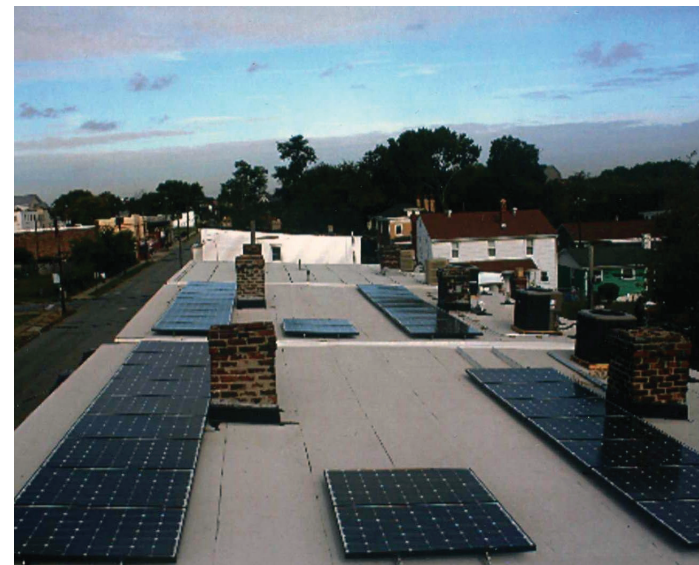
Recommended: [76-77] Solar panels, which also serve as awnings, were installed in secondary locations on the side and rear of this historic post office and cannot be seen from the front of the building. [78] Solar panels placed horizontally on the roof of this historic building are not visible from below.

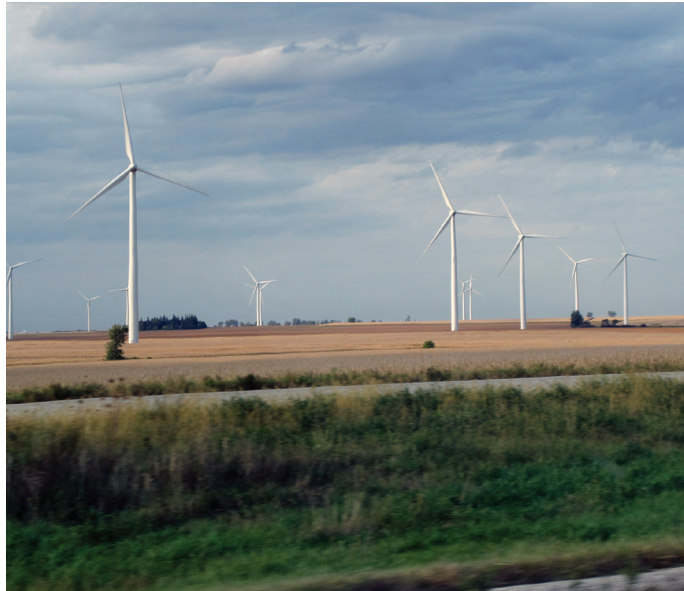
Recommended: [80] It is often best to install wind-powered equipment in off-site, rural locations to avoid negatively impacting a historic building and its site.

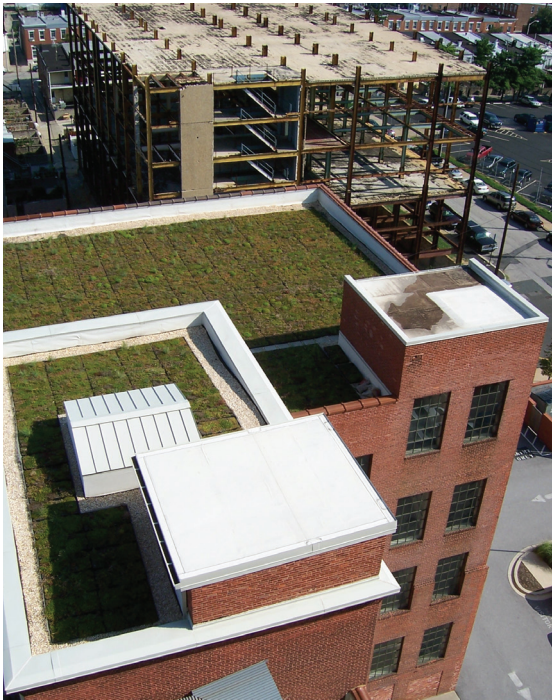
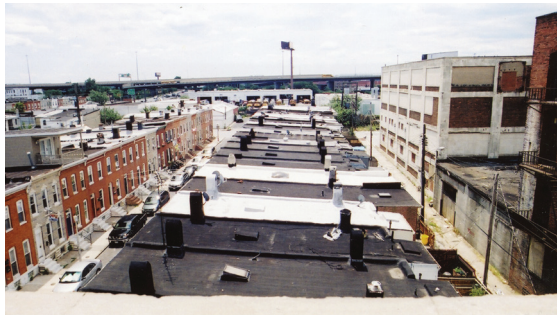
Recommended: [85-86] A cool or green roof is best installed on a flat roof where it cannot be seen from the public right of way and will not negatively impact the character of the historic building.

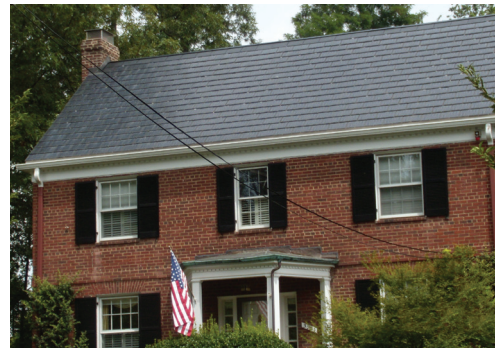
Not Recommended: [87] Historic roofing materials in good condition should be retained rather than replaced with another material perceived as more sustainable, such as, in this case, solar roofing shingles.

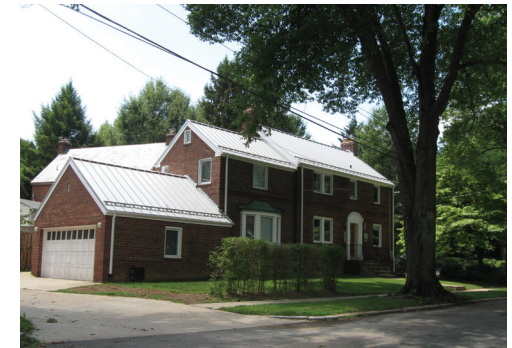
Not Recommended: [88] This new, cool white metal roof is not an appropriate material or color for this historic mid-20th century house.

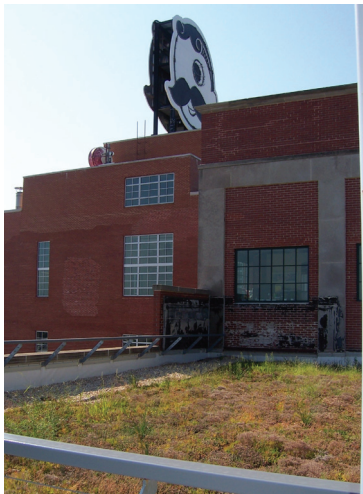
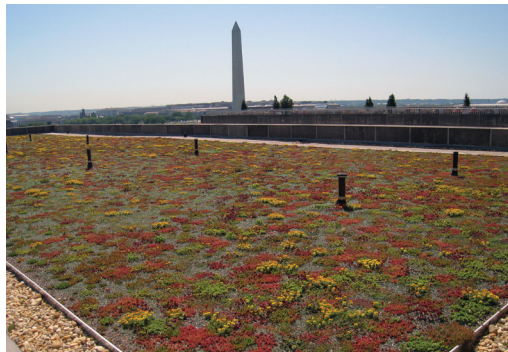
Recommended: [89-92] Low-scale and sustainable native plants are appropriate for these roof gardens on historic buildings.

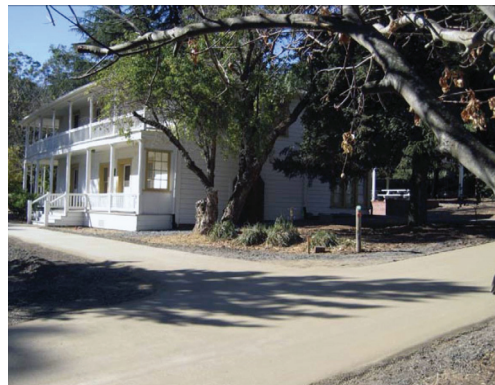
Recommended: [94-95] Permeable pavers were used at this historic residential property for a driveway and parking (above) and a hard-packed, construction aggregate provides environmentally-friendly paths for visitors at this historic site (below).

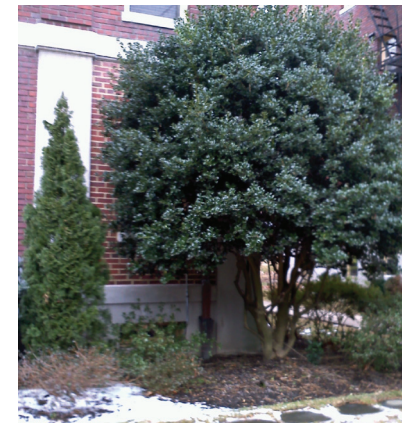
Not Recommended: [97] This tree, which was planted too close to the building, has caused the masonry wall to retain moisture that damaged the mortar and required that the brick be repointed in this area.

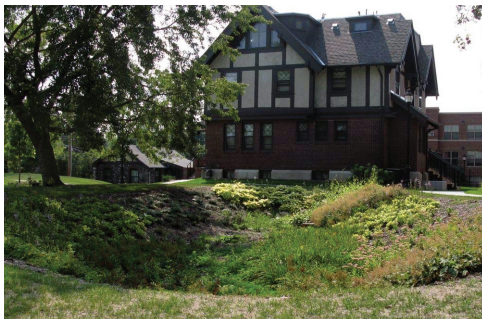
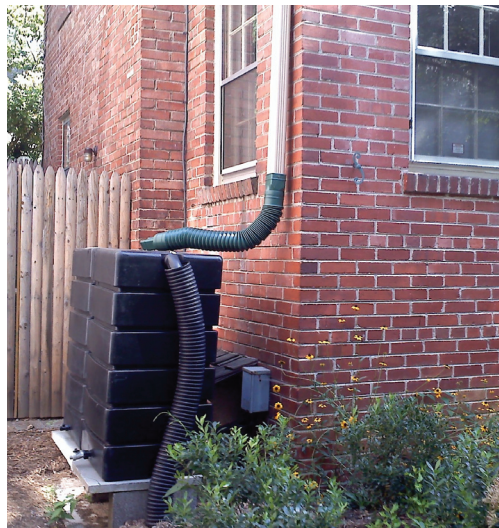
Recommended: [98-100] Rain gardens and rain-water collection tanks are features that may be added to a historic property to improve storm-water management and increase on-site water use.

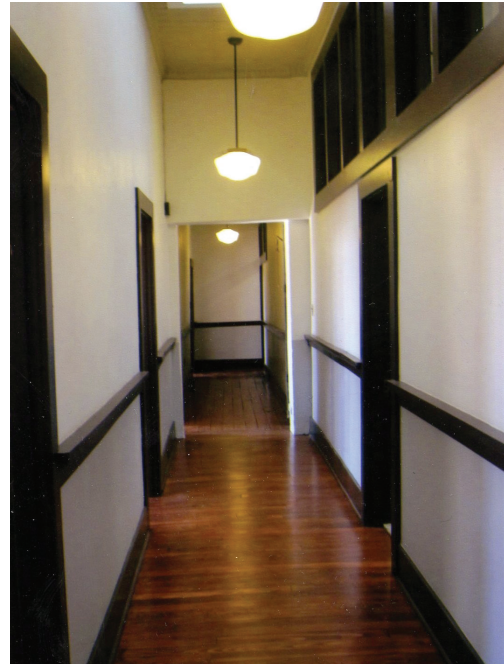
[108-109] The original, partially-glazed doors and office partitions, as well as skylights, that let natural light into the corridors were retained as part of the rehabilitation of this early-20th century building.
