# **Demonstration and Validation of Materials for Corrosion-Resistant Fencing and Guard Railings in Aggressive Climates**

Final Report on Project F09-AR02

October 2015

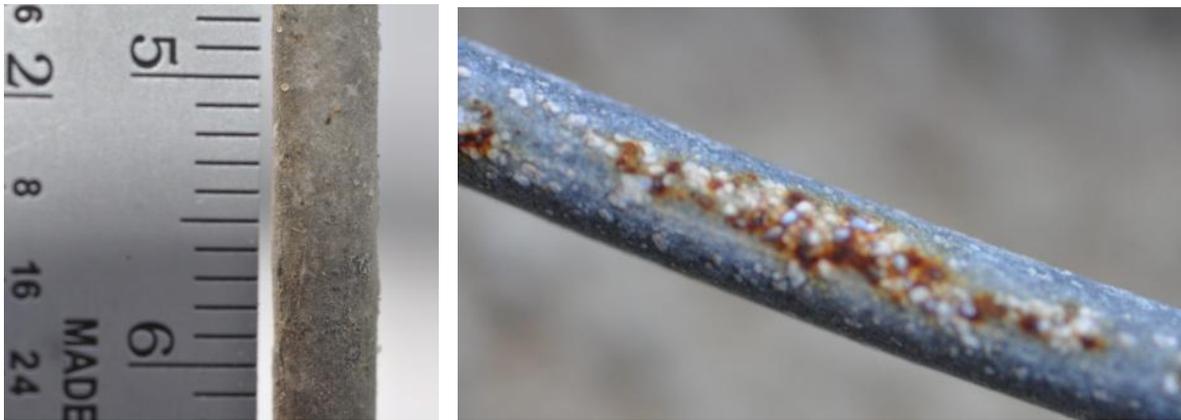
Figure 23. Standard galvanized steel wire coupon at FRF (left) and KTA (right) after 12 months of exposure.

Fencing Material Type	% of Surface Corroded	Type	Comments
Standard PVC coated galvanized	0%	N/A	No visible corrosion
Fuse bonded PVC coated galvanized	0%	N/A	No visible corrosion
Standard galvanized	50%	Oxidation / Rust	50% of the corrosion areas have degraded past the sacrificial zinc coating and have begun to rust.
Stainless steel	100%	Oxidation	Surface oxidation
Aluminum	5%	Pitting	Minor pitting
Galfan	75%	Oxidation / Rust	50% of the corrosion areas have degraded past the sacrificial zinc coating and have begun to rust.
Aluminized steel	<5%	Oxidation	White oxidation of the zinc/AL coating

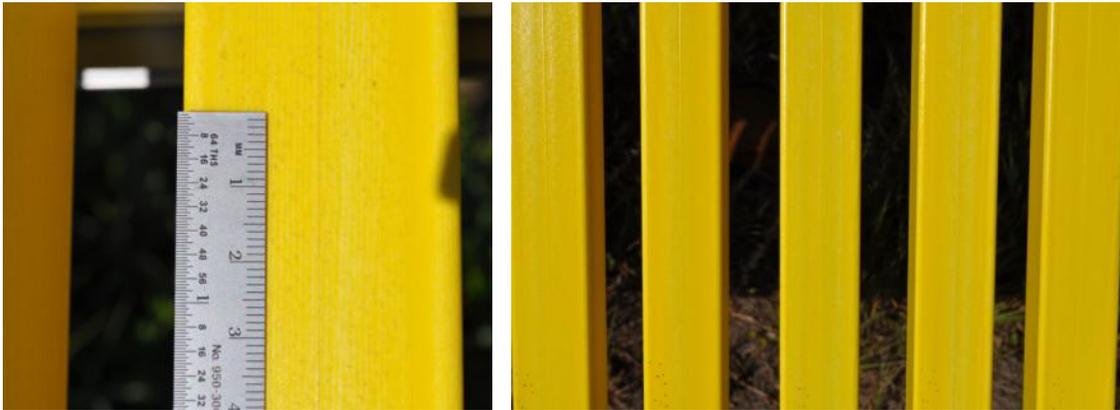
Figure 29. FRP railing coupon at FRF (left) and KTA (right) after 6 months of exposure.

months of exposure. The FRP railings did not show signs of degradation until 6 months of exposure. The sides of railing specimens that face the sun the longest during the day were affected by color fading.

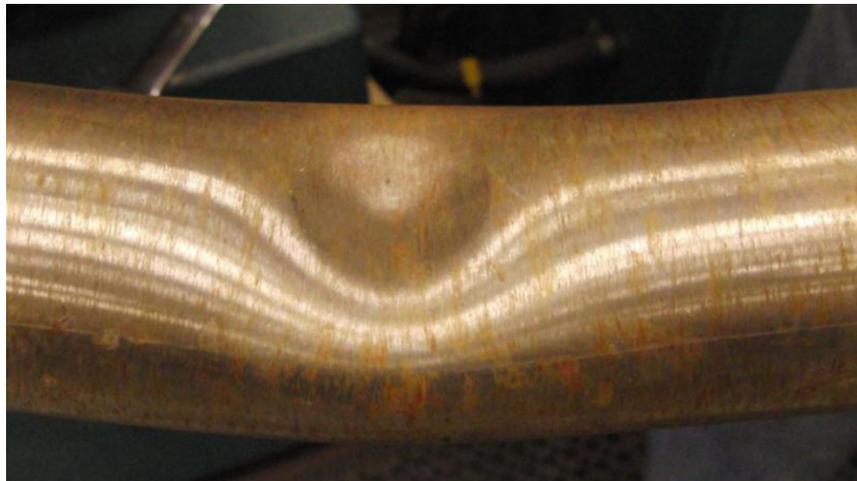
Figure 47. Cross sectional collapse of a stainless steel pipe under flexure testing.

Figure 46 shows a typical graph of steel pipe deformation as a flexure load is applied. It was found that the longitudinal shape of the pipe remained rigid and the circular cross section collapsed before the pipe began to flex, as seen in Figure 47. This same behavior was not observed in the aluminum or FRP railing specimens. The aluminum specimens were relatively ductile in comparison with steel and stainless steel, and therefore began to deform in both the cross section and longitudinally at the same time. The FRP railing had a square cross section and is not very ductile compared to either steel or aluminum, so its failure was different than the metallic specimens. Figure 48 – Figure 50 represent the change in the tangent modulus throughout the exposure period for each test site. More data can be found in Appendix E.

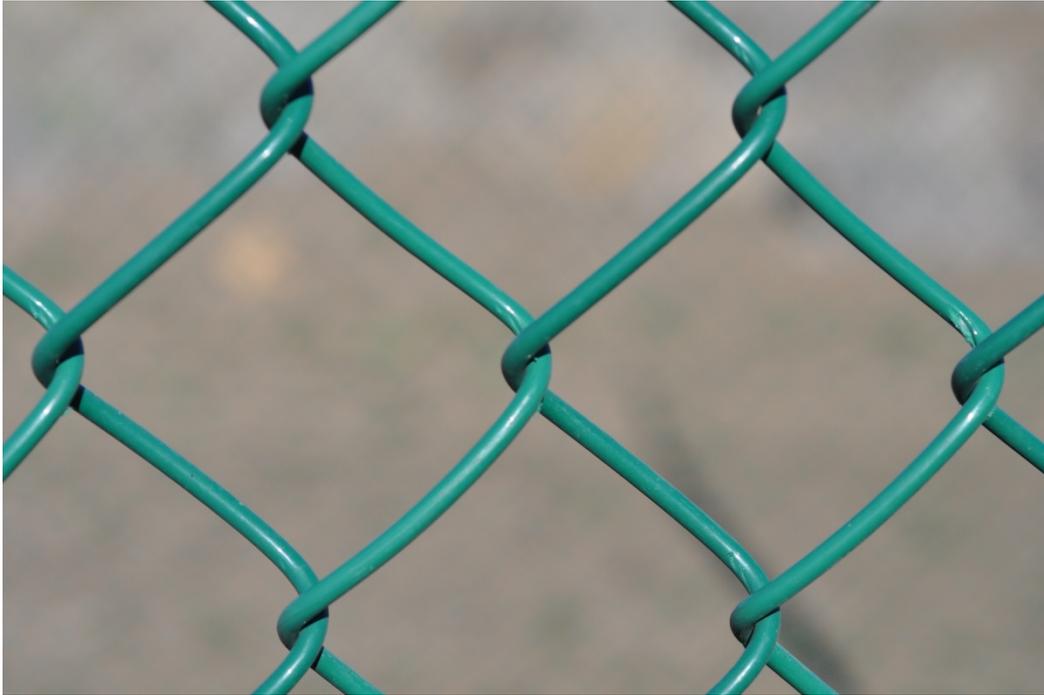
Figure A7. Fuse-bonded PVC after 6 months exposure.

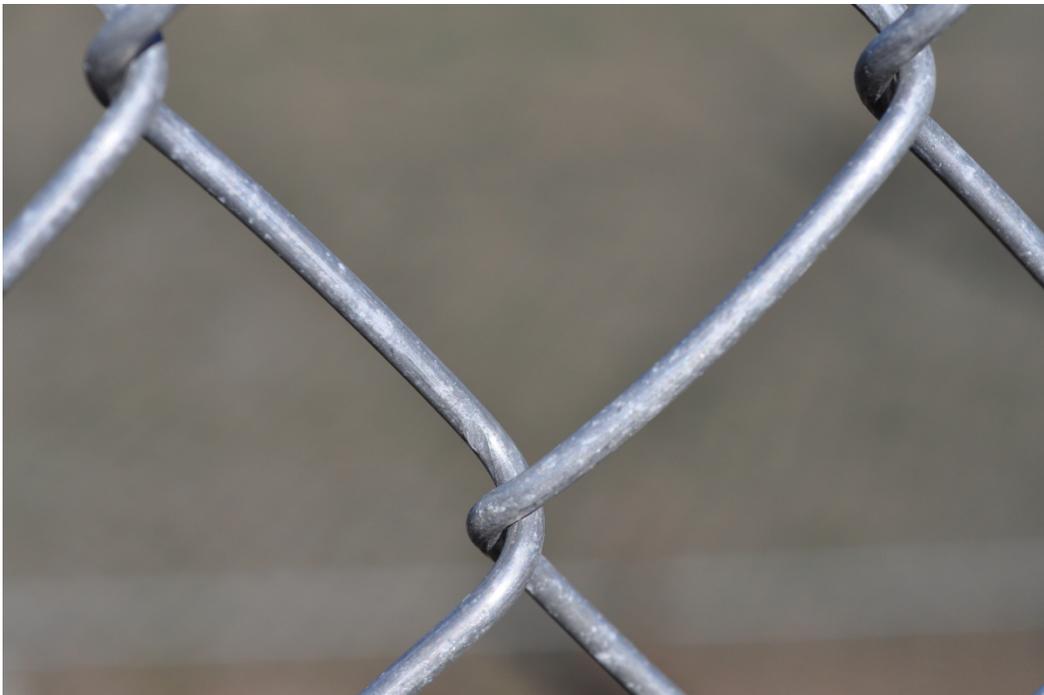
Figure A8. Stainless steel after 6 months exposure.

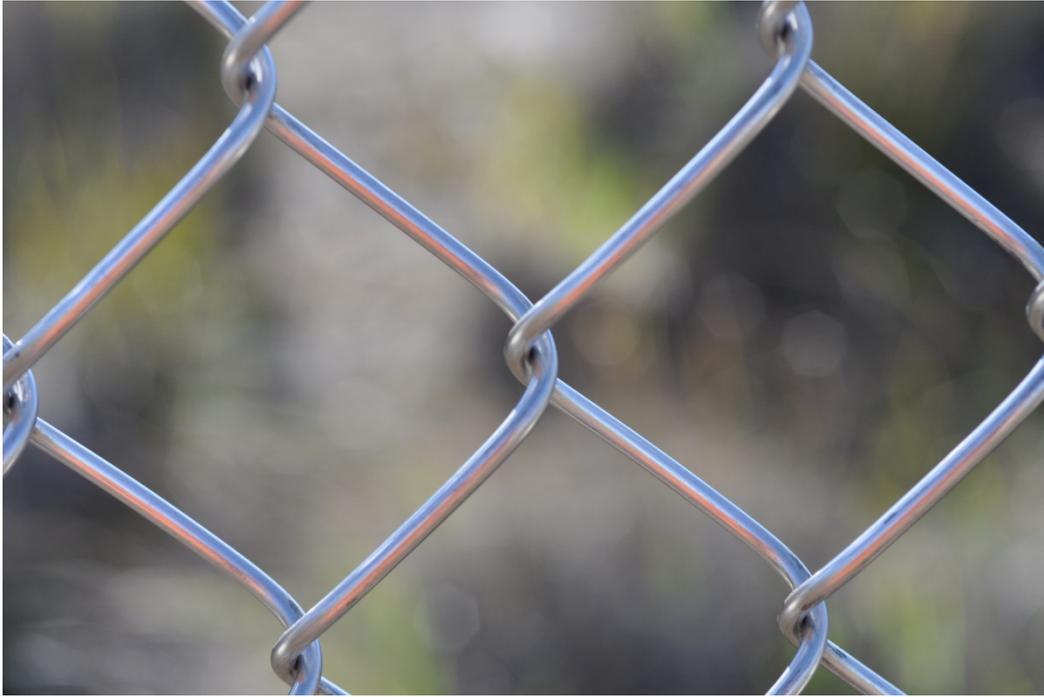
Figure A9. Aluminum after 6 months exposure.

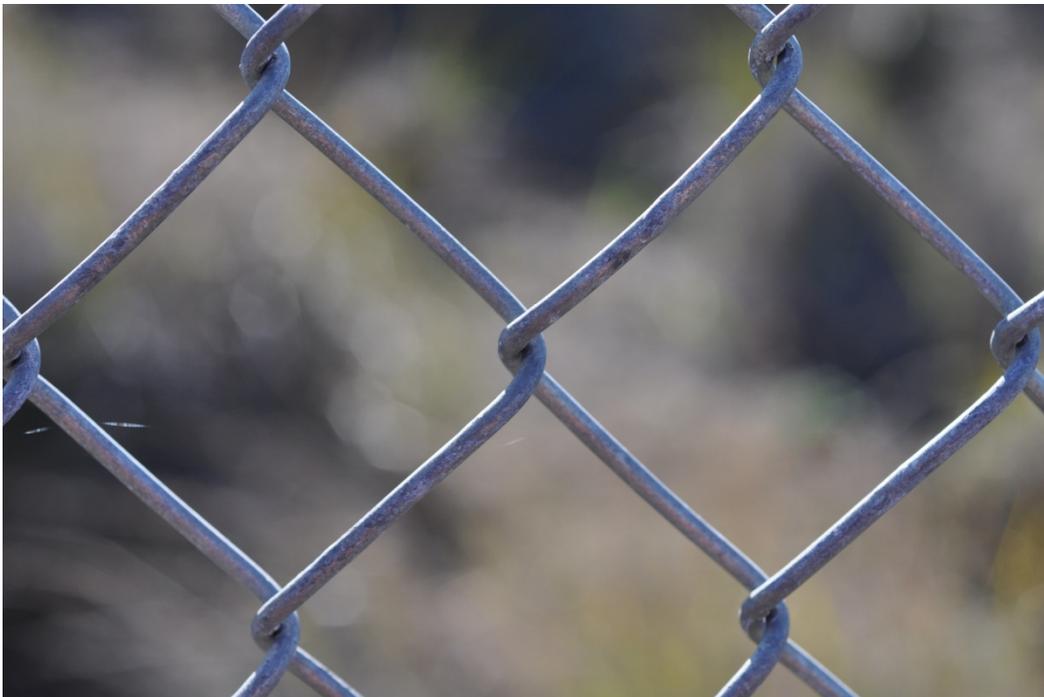
Figure A10. Galvanized steel after 6 months exposure.

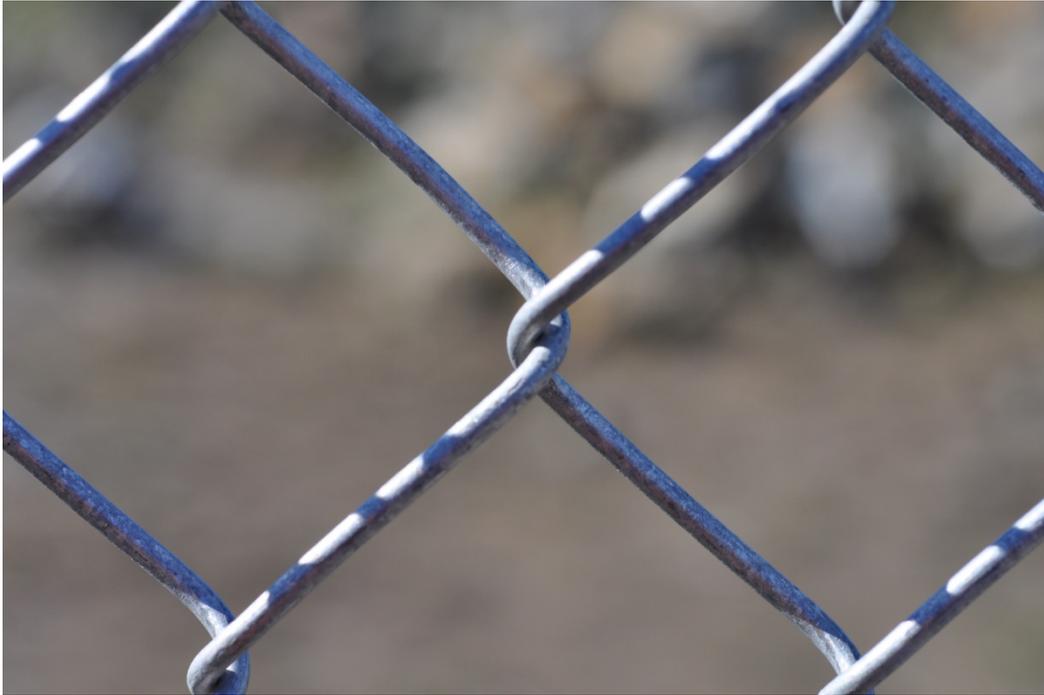
Figure A11. Aluminized after 6 months exposure.

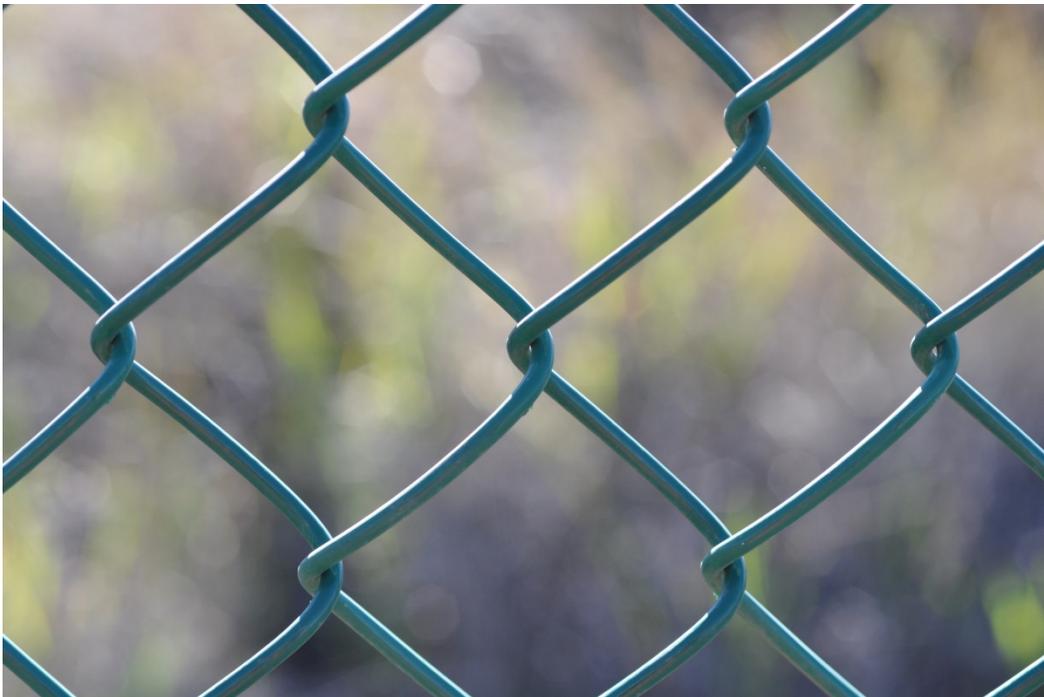
Figure A12. Standard PVC after 6 months exposure.

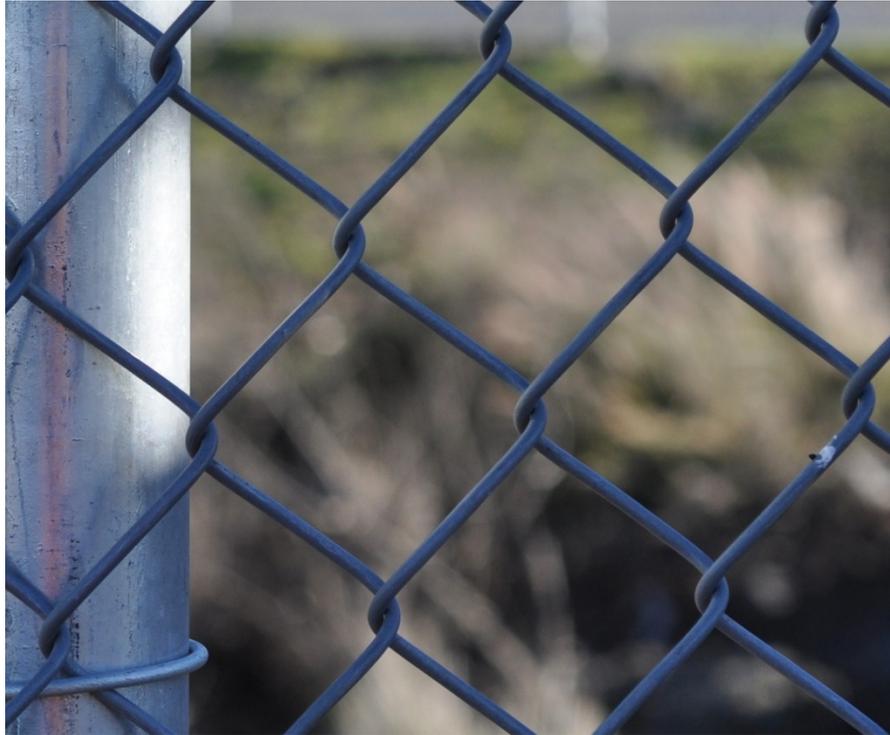
Figure A13. Galvan PVC after 6 months exposure.

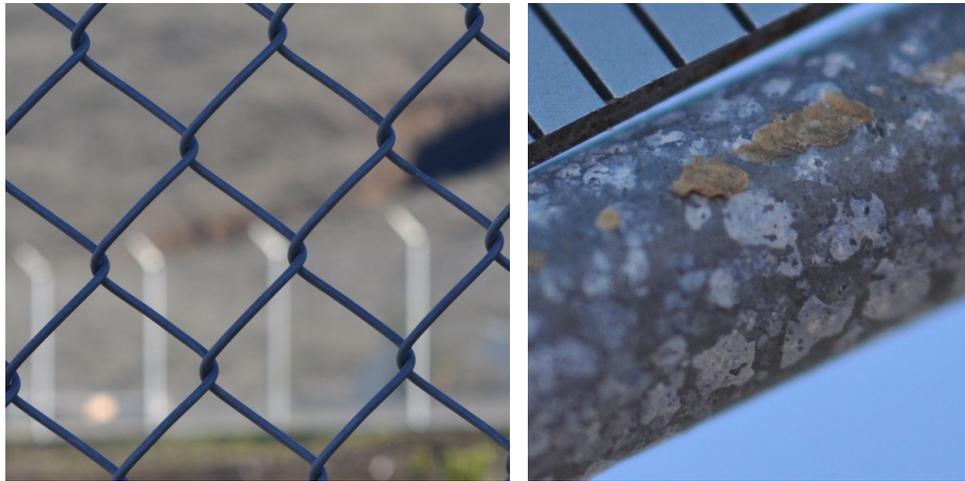
Figure A16. Galfan showing localized corrosion on 10% of its total surface after 12 months exposure.

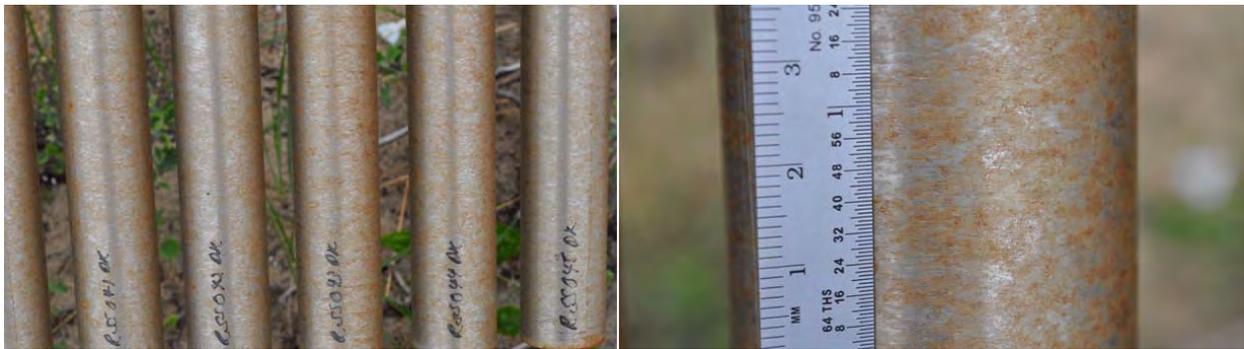
Figure B4. Coated Steel Railing

Std Galvanized	10%	Oxidation	White oxidation of the zinc sacrificial coating
<b>Railing Coupons</b>				
	Stainless Steel	50%	Oxidation	Surface oxidation has discolored the material.
	Aluminum	<5%	Pitting	Pitting has begun in areas where the anodize may have been damaged
	Coated Steel	10%	Rust	Rust has begun to form where the coating has failed. Discoloring of the coating due to the rust.
	FRP	0%	N/A	No visible corrosion
<b>Fabricated Railing</b>				
	Stainless Steel	95%	Oxidation	Surface oxidation has discolored the material.
	Aluminum	<5%	Pitting	Pitting has begun in areas where the anodize may have been damaged
	Coated Steel	10%	Rust	Rust has begun to form where the coating has failed. Coating around the rust has begun to blister. Discoloring of the coating due to the rust.
	FRP	0%	N/A	No visible corrosion

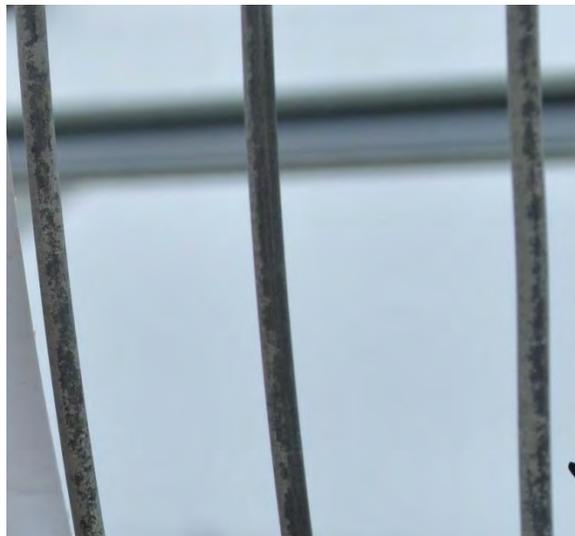
Figure B14. Fuse Bonded PVC Coated Galvanized Wire Coupon

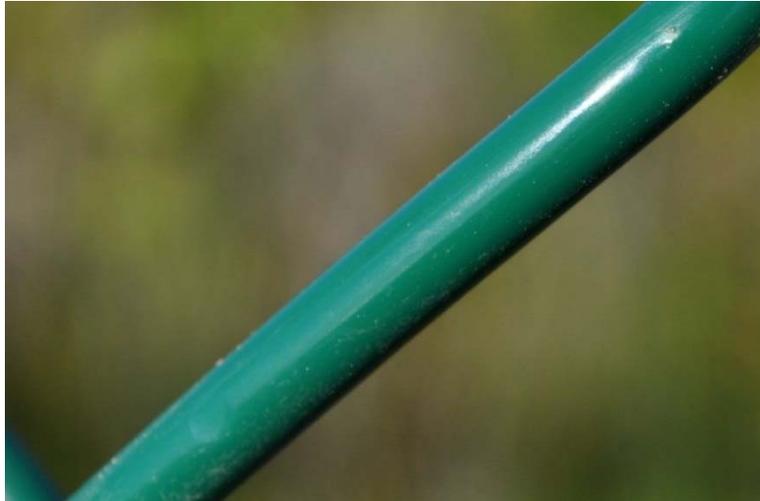
Figure B15. Fuse Bonded PVC Coated Galvanized Wire Fencing

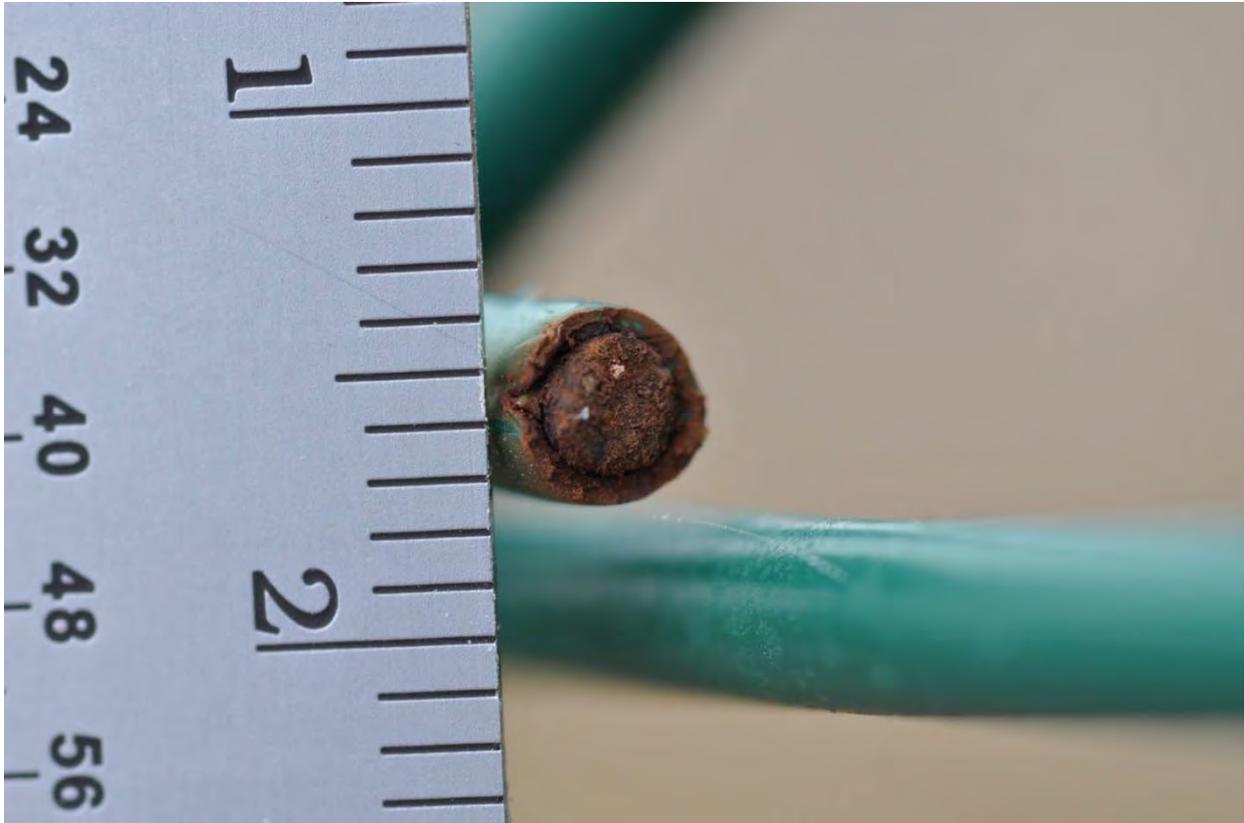
*Figure B64. Fuse Bonded PVC Coated Galvanized Wire Fencing Cut Ends*

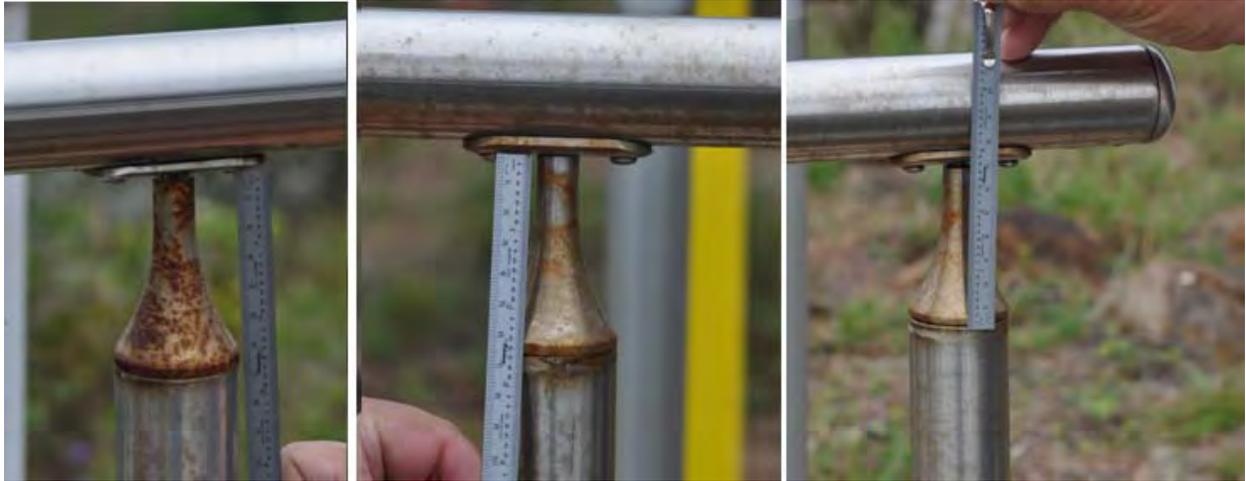
Figure B65. (Left) Southern most stainless steel T-fitting, (Center) center stainless steel T-fitting, (Right) northern most stainless steel T-fitting.

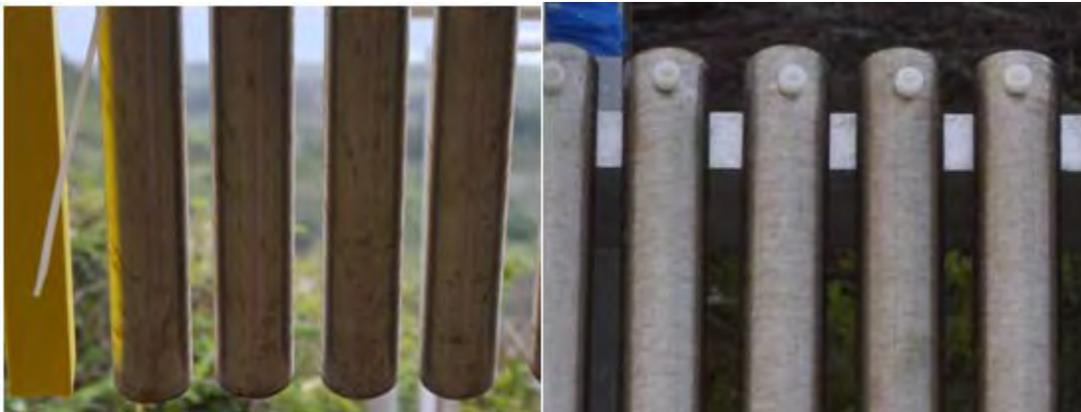
Figure B66. (Left) Stainless steel coupons facing away from the ocean; (Right) stainless steel coupons facing the Ocean.

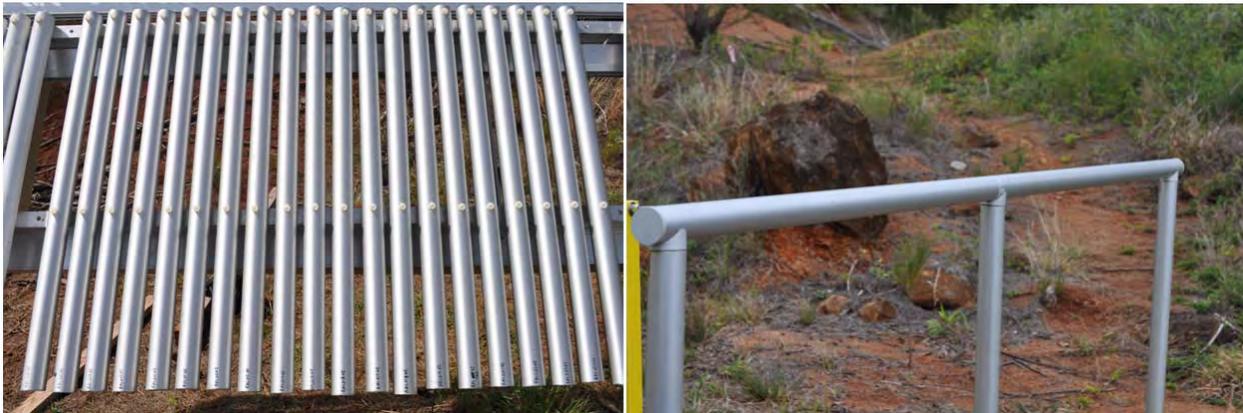
Figure B69. (Left) Aluminum railing coupons. (Right) Aluminum railing test section.

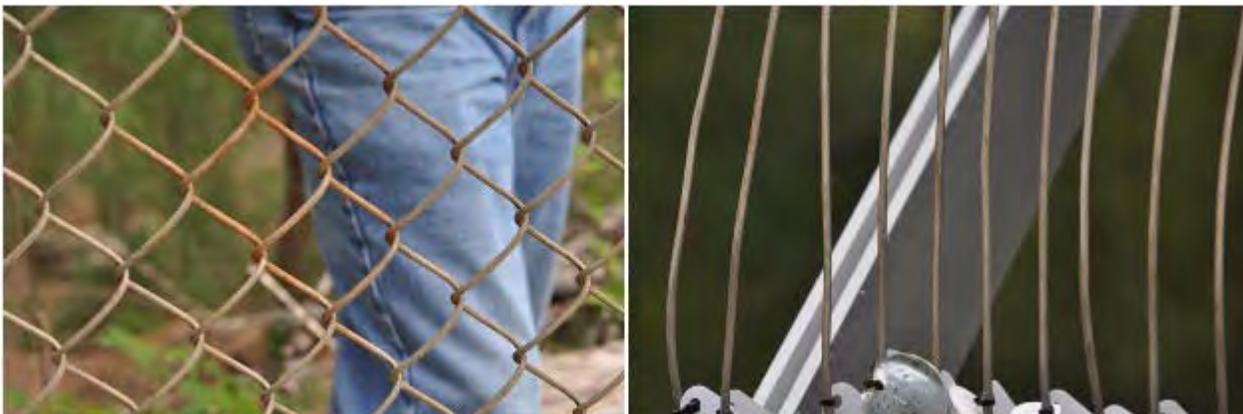
Figure B70. (Left) Stainless steel fence after 3 months exposure.  
(Right)Stainless steel wire coupons after 3 months exposure.

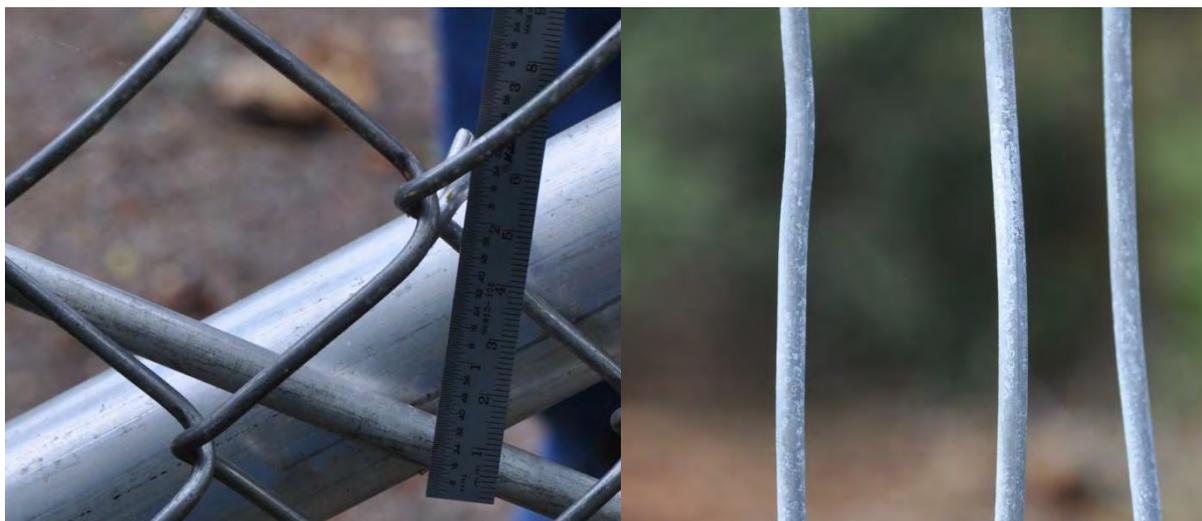
Figure B73. (Left) Galfan fabricated fencing. (Right) Galfan Wire Coupons

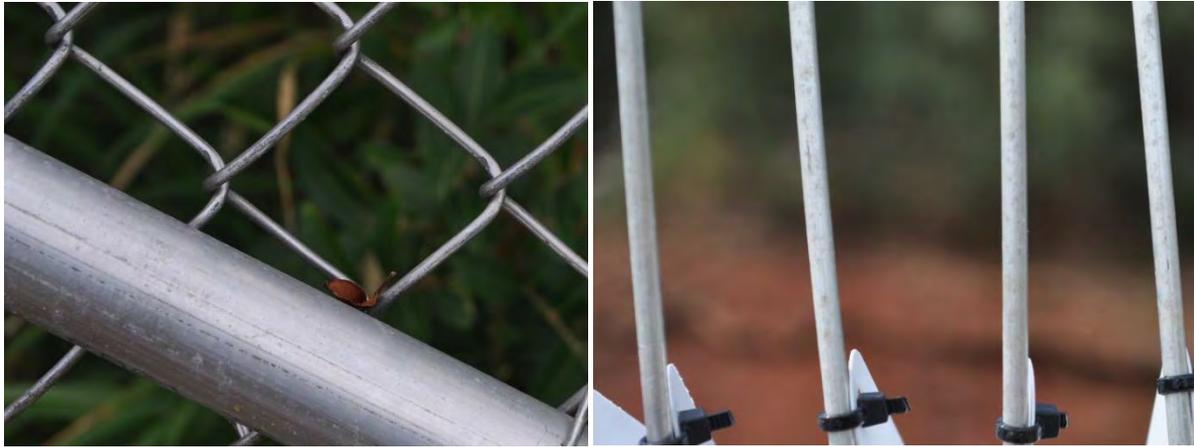
*Figure B74.* (Left) Aluminum fabricated fencing. (Right) Aluminum Wire Coupons

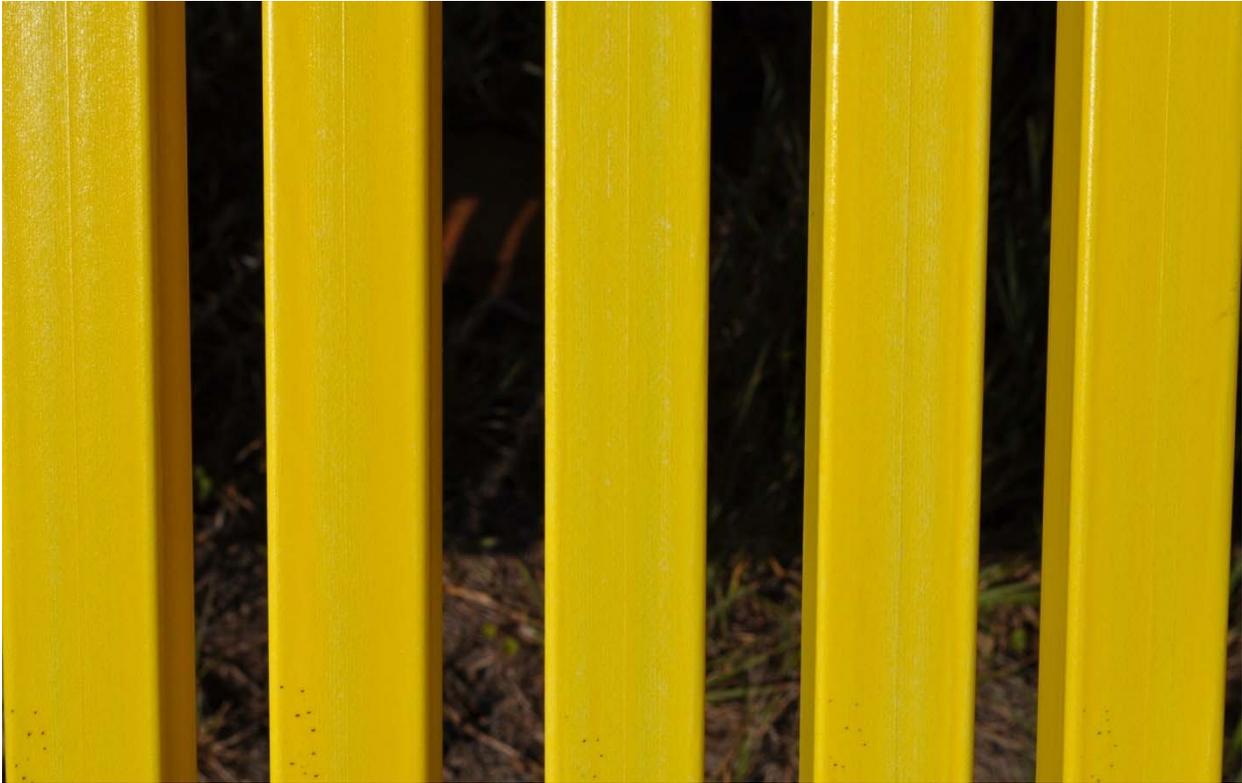
Figure B77. FRP Railing Coupon

Coated Steel	10%	Rust	Rusting areas have spread larger causing blistering under the coating.
	FRP	25%	UV	Discoloring due to UV exposure on the face of the railing that faces the sun

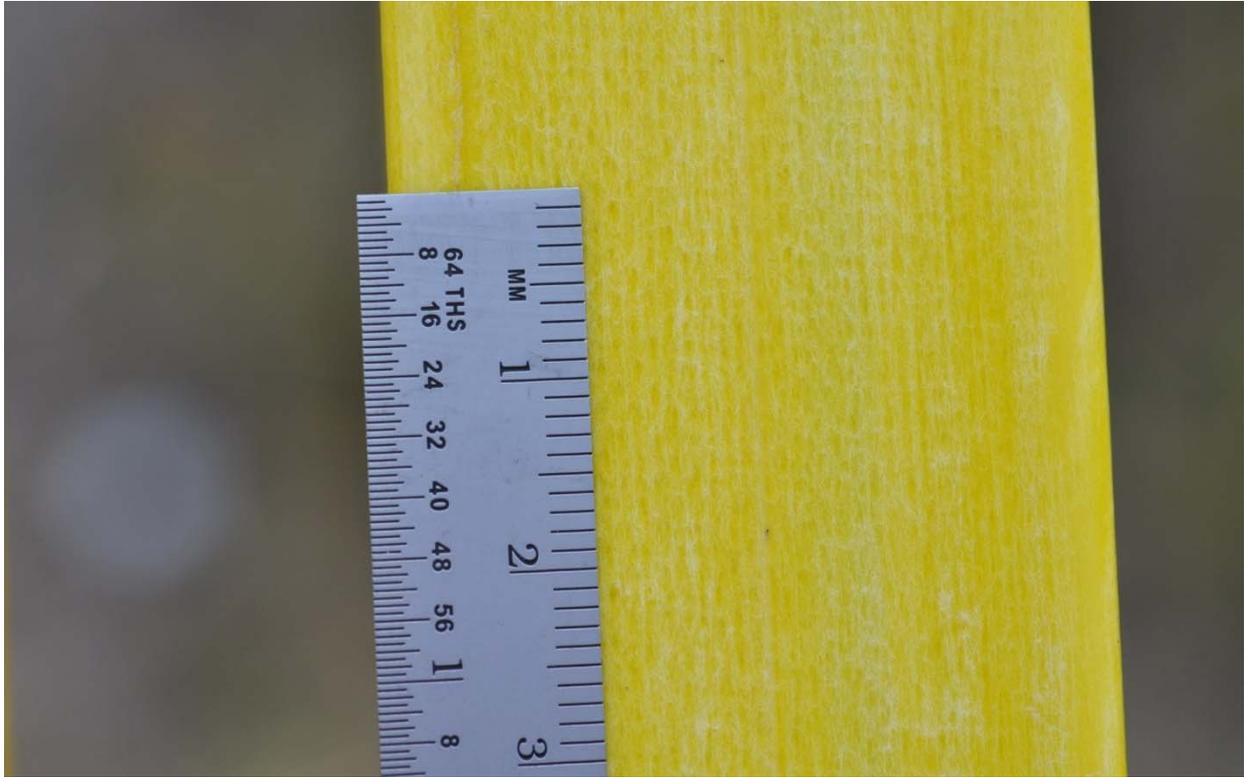
Figure B97. FRP Railing Coupon

Fuse Bonded PVC Coated Galvanized	<5%	Rust	Minor rust has begun to form around cut ends and damaged areas
<b>Railing Coupons</b>				
	Stainless Steel	80%	Oxidation	Surface oxidation has discolored the material.
	Aluminum	<5%	Pitting	Pitting has begun in areas where the anodize may have been damaged
	Coated Steel	10%	Rust	Rust has begun to form where the coating has failed. Discoloring of the coating due to the rust.
	FRP	25%	UV	Discoloring due to UV exposure on the face of the railing that faces the sun
<b>Fabricated Railing</b>				
	Stainless Steel	50%	Oxidation	Surface oxidation has discolored the material. T-fittings show 90% surface corrosion likely due to lack of passivation.
	Aluminum	<5%	Pitting	Pitting has begun in areas where the anodize may have been damaged
	Coated Steel	20%	Rust	Rusting areas have spread larger causing blistering under the coating.
	FRP	25%	UV	Discoloring due to UV exposure on the face of the railing that faces the sun
